CASE STUDY

Online Risk Monitoring of CUI for Cold Insulation Pressure Vessels and Pipes

Dynamic Risk Assessment of LPG pipeline in arid climate in Saudi Arabia.

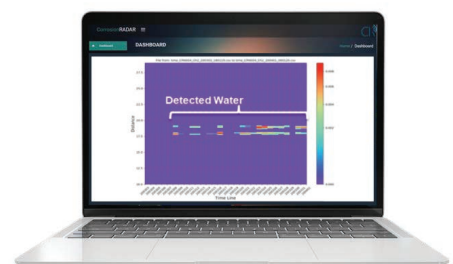
CorrosionRADAR's Moisture and Corrosion Sensors are permanently embedded under the insulation to detect the presence of water and monitor corrosivity levels - providing an online assessment of CUI risk on the pipe.

The data from sensors are analysed using **CR CUI Risk Analytics Software**.

The output is then presented in traffic-light risk levels to make data-driven decisions for inspection scoping and planning.

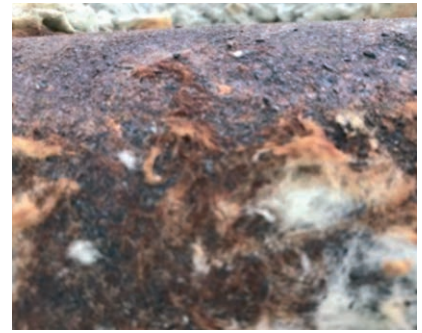
Since deployment, **CorrosionRADAR's Moisture Sensors** have successfully detected and monitored cycles of water penetration through the insulation.

CorrosionRADAR's Corrosion Sensors have successfully monitored the corrosivity levels within the insulation and detected the presence of CUI - enabling an early intervention.

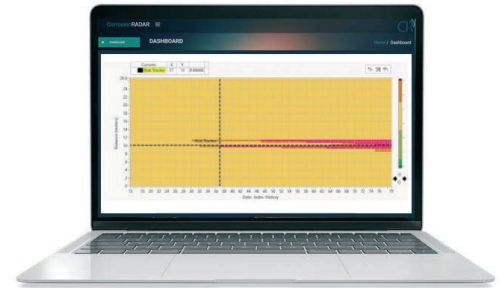
- The key assumption was that the insulation system with FOAMGLAS is vapour sealed and hence no condensation should occur on the pipe surface which can lead to corrosion
- The **CR Sensors** were installed under the insulation during a shutdown. Continuous monitoring revealed presence of moisture thereby confirming compromised vapour seal of insulation
- The **CR CUI Risk Analytics** assessed the corrosive conditions under insulation to be at 'High Risk' of CUI and upon a scheduled inspection, high levels of corrosion was observed
- Without **CorrosionRADAR** technology, this level of corrosion would have gone unnoticed which could have led to a dangerous leak on the pipe and an unscheduled shutdown.

CUI PoF Quantified: Very High

The ability to monitor wetness cycles within insulation coupled with CUI RISK analytics, enabled the client to take early corrective actions to avoid corrosion
