CASE STUDY

Flexible Solutions for Corrosion Detection in Critical Process Equipment

Installation of a system for continuous online corrosion monitoring of four assets: horizontal pipeline; column; vertical pipe; column manholes.

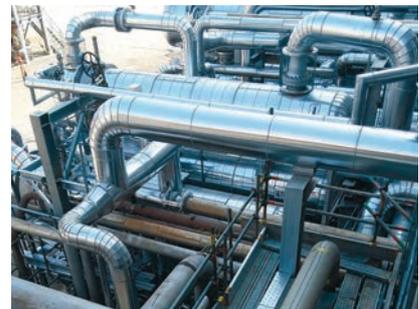
Current RBI programmes lead to high maintenance costs and unnecessary system downtime.

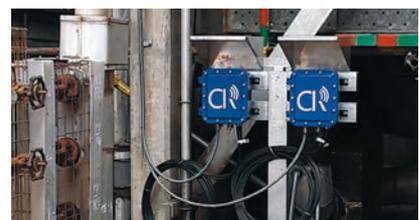
CR corrosion sensor mounted along a horizontal pipeline.

The system comprises long thin flexible sensors, installed permanently underneath the equipment's insulation. Electro-Magnetic Guided Radar (EMGR) waves are sent through the sensor, with reflections pinpointing areas of corrosion. Sensor data is transmitted wirelessly, with a choice of communications protocols including 3G, 4G, LoRa, WirelessHART and WiFi. Data can be held on local servers or a cloud platform.

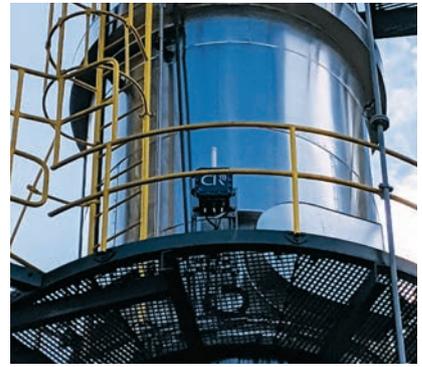
The ability for continuous remote assessment of CUI paves the way for more conditional data-driven RBI using continuous monitoring, enabling preventative rather than reactive maintenance.

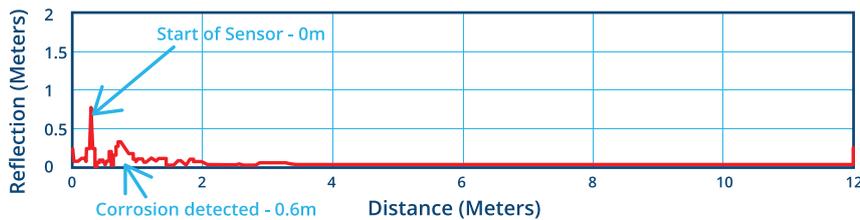
Sensor data pinpointed corrosion at 0.6m on the vertical pipeline. The steady decrease in signal strength from the first point of detection indicates propagation of corrosion.

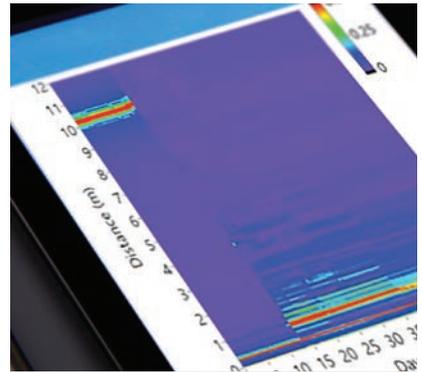
2D amplitude plot of data from when corrosion was first detected. The first peak represents the transition from bridge cable to sensor while the second indicates the presence of corrosion.
