CASE STUDY

Corrosion Monitoring of Assets at Solvay

Corrosion monitoring of four assets: horizontal pipeline; column; vertical pipe; column manholes.

Solvay –
Torrelavega Plant, Spain

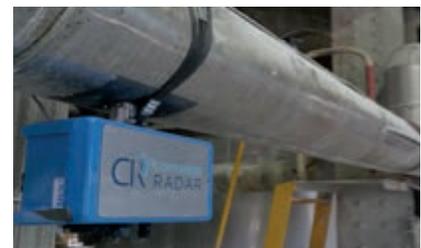
CR corrosion sensor mounted along a horizontal pipeline.

Solvay and CR collaborated in the deployment of CR technology in Torrelavega, Spain. The Corrosion Monitoring System was installed on four assets: a horizontal pipeline; the base of a column; a vertical pipe; and around column manholes.

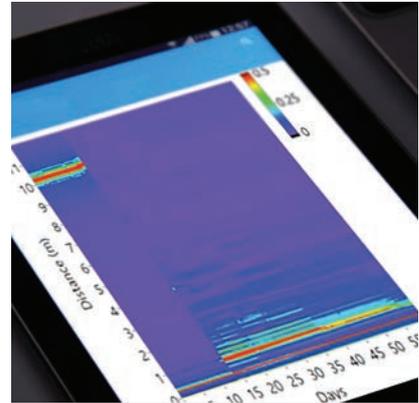
Sensor data pinpointed corrosion at 0.6m on the vertical pipeline. The steady decrease in signal strength from the first point of detection indicates propagation of corrosion. These results were confirmed by visual inspections performed by Solvay.

- All four systems have achieved 100% uptime, transmitting information on asset health and CUI levels for analysis
- Corrosion has been detected on two of the four assets and, after consultation with Solvay, visual inspections carried out. Results of these inspections strongly supported sensor data and necessary repairs were undertaken in areas of corrosion
- The ability to remotely detect corrosion paves the way for more data-driven RBI, enabling preventative rather than reactive maintenance. This is made possible through the use of CR's Industrial Internet of Things (IIoT) systems, supporting the move towards Industry 4.0.

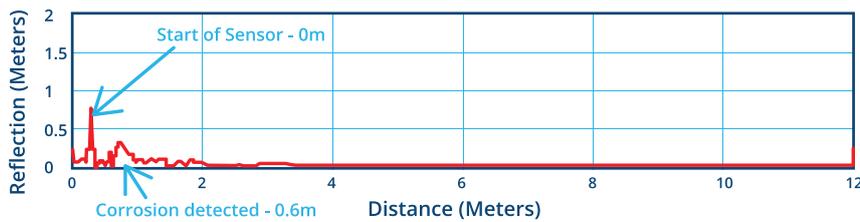
2D amplitude plot of data from when corrosion was first detected. The first peak represents the transition from bridge cable to sensor while the second indicates the presence of corrosion.
